CALIFORNIA DIVISION OF MINES AND GEOLOGY
FAULT EVALUATION REPORT FER-243
SAN ANDREAS FAULT, SHELTER COVE AREA, HUMBOLDT COUNTY

by
Earl W. Hart
December 3, 1996

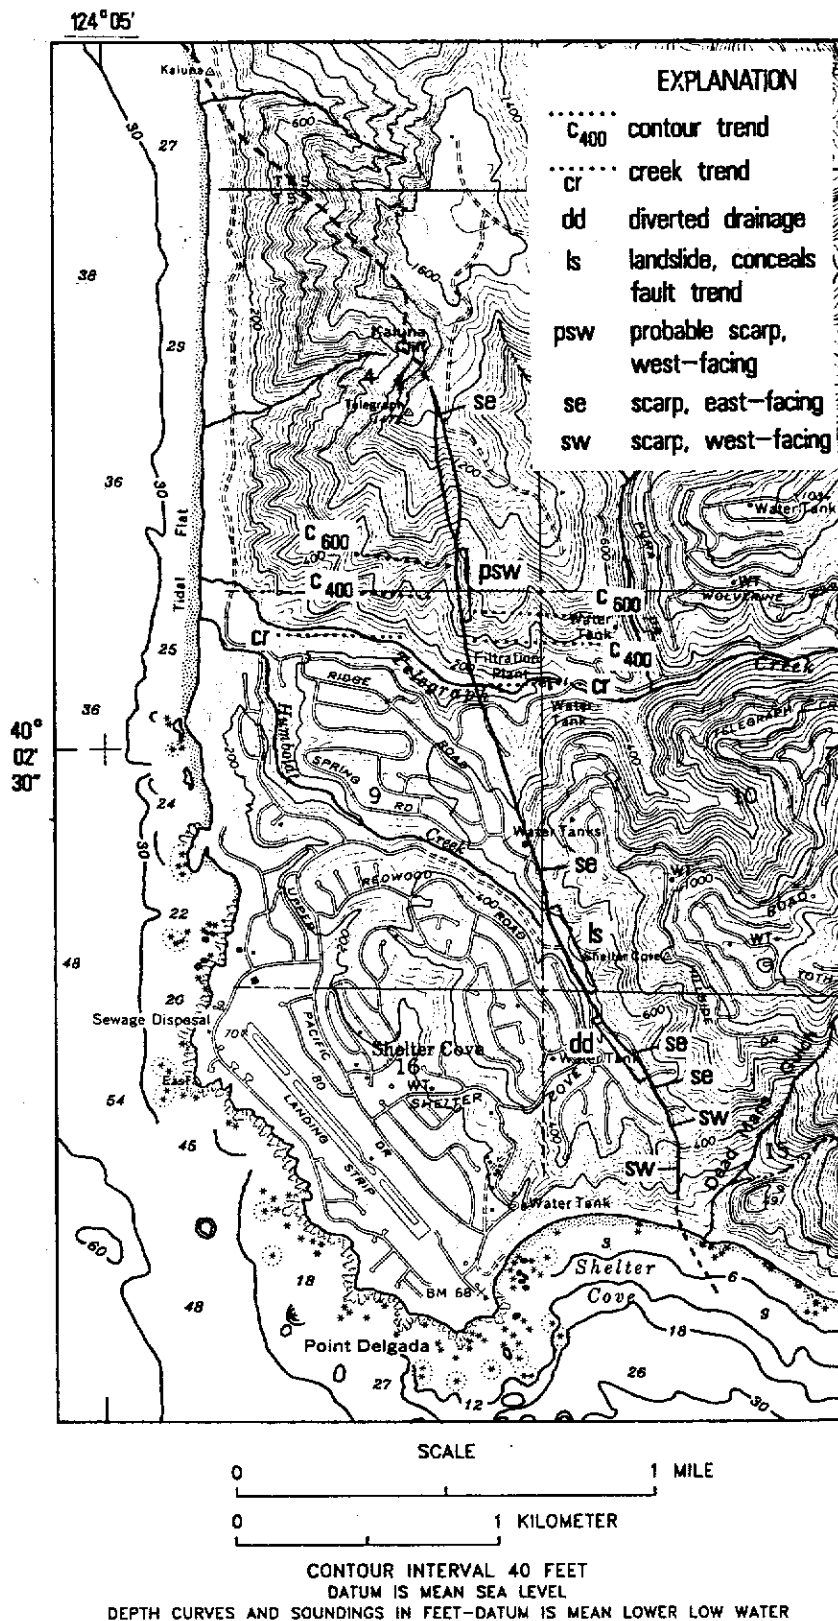
Figure 3 (FER-243). Location and geomorphic evidence of main trace of San Andreas fault at Shelter Cove (from R.D. Brown, 1994, Fig. 4).

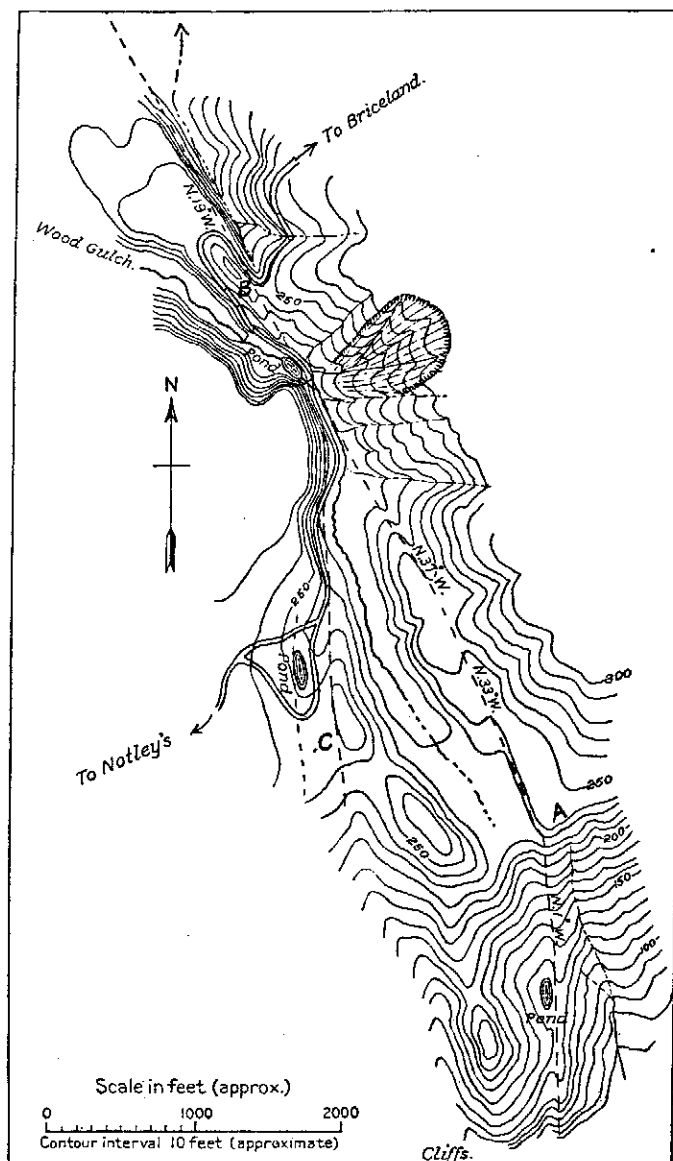
According to Matthes, the ruptures extended from the coast at Shelter Cove (Deadman Gulch) to "Telegraph hill" (Figure 5).

He was unable to trace the fault to the north due to extensive landslides. Matthes also mapped three subsidiary faults (C, D, and E on Figure 5), but he does not describe the sense or magnitudes of slip other than to comment that 1) fault C is less pronounced than the main trace and that horizontal displacement is small and 2) fault D has a marked depression but that a fence crossing it showed no sign of horizontal shifting (although he speculates that the fence may have been repaired since the earthquake). He also portrayed fault trace E with queries, suggesting a lower degree of confidence as to the designation or location of this feature.

Figure 5 (FER-243). Sketch maps of 1906 San Andreas fault rupture at Shelter Cove by F.E. Matthes (from Lawson, 1908, Figs. 10 and 11).

(FIG. 10).—Map of country traversed by fault to north of Shelter Cove, Humboldt County.

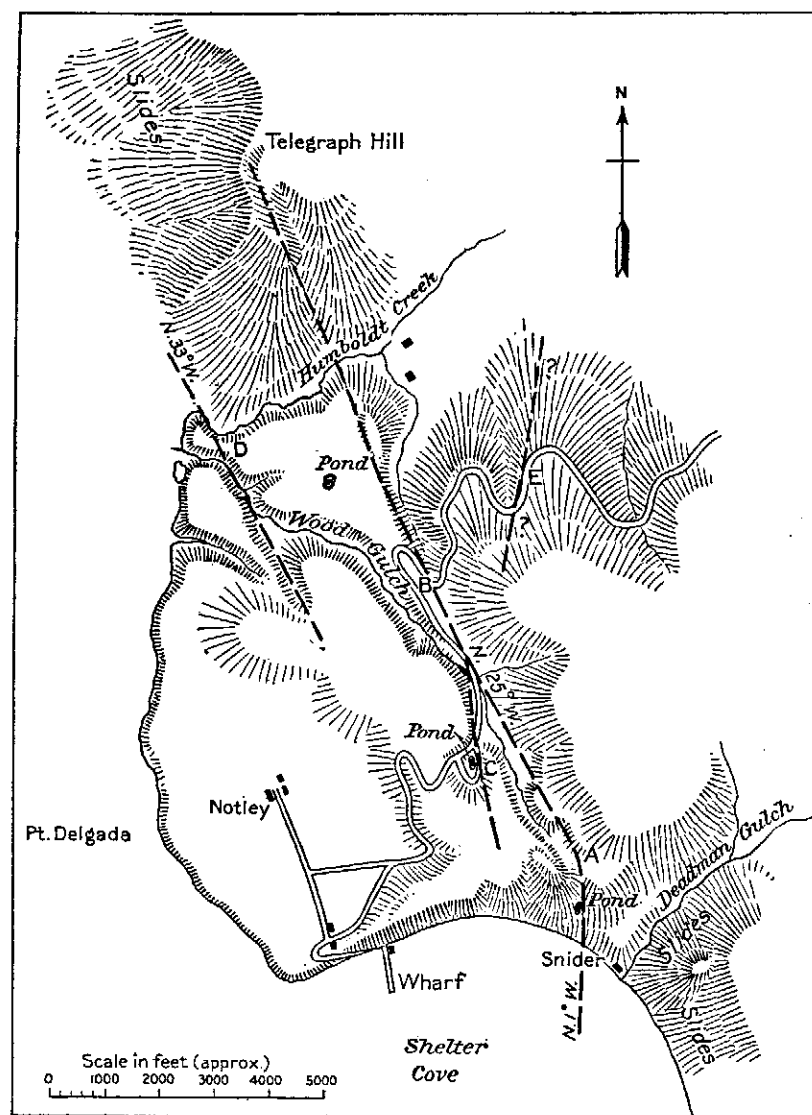
The subsidiary faults of Matthes also were evaluated (Figure 5). Fault C of Matthes is probably the same as the linear trough with two closed depressions mapped by this writer at locality 19 (Figure 7). This feature is very fresh-looking on the 1941 photos and no doubt ruptured in 1906. To the southeast a very fresh, west-facing scarp and three interconnecting southeast-facing scarplets -- all without vegetation on the 1941 photos -- also may be 1906 ruptures. However, whether they are caused by faulting or landsliding (landslide deposits and shears are prominently displayed in the cliffs below) is difficult to determine. Both the linear trench and main scarp extend into large erosional gullies that drain into Shelter Cove. At the base of the cliff, a terrace deposit reported to be about 44,800 years old (McLaughlin and others, 1983) is significantly deformed. Approximately at locality 20, a north-trending shear zone offsets the marine-nonmarine terrace contact about 1.5 or 2 m (5 or 6 ft) down to the east. This may coincide with the gully projection of the linear trough that reportedly ruptured in 1906. A few hundred feet to the east, the terrace sequence is folded into a syncline near the gully projection of the west-facing scarp. Farther to the east, the young terrace deposits are abruptly downwarped and possibly faulted against sheared and

Subsidiary fault D of Matthes (Figure 5) also may be identified on the 1941 and 1954 air photos at locality 21 (Figure 7). Here a very fresh, 150 m (500 ft) long linear, northeast-facing scarp can be seen on the low ridge between Telegraph and Humboldt Creeks. This feature cannot be followed continuously to the southeast (as mapped by Matthes) due to the presence of landslides, some of which have very fresh-scarps that also may have been active in 1906 along the south flank of Telegraph Creek. Other youthful landslide features also occur to the southeast on both sides of Humboldt Creek, which shows a large right-lateral deflection. According to Matthes, fault D could be traced "to the south over the grassy hills [where] it is found to disappear somewhere near the head of a little gulch shown on the map." The gulch referred to may be at locality 22, which is a linear gulch flanked by a sharp east-facing scarp. This scarp appears to be truncated to the south by a east-west trending landslide scarp. However, other northwest-trending features (subtle scarp, trough) can be seen on the airphotos farther to the southeast. The airphotos suggest no surface connection between localities 21 and 22, except for short east-facing scarp in a landslide(?). Although it is possible that Matthes may have partly mistaken landslide ruptures for faults, he made a major point of being able to distinguish between strike-slip fault and landslide features. I was unable to verify the suggestion of McLaughlin and others (1985) that this trace of the fault has been "largely inactive" in the last 13.8 ± 4 Ma.

Subsidiary fault E of Matthes could not be verified by geomorphic features on the airphotos or on the ground. However, a linear, northeast-trending trough was identified at locality 23 about 200m (650 ft) west of the assumed location of his trace E (Figures 2, 5 and 7). This 300m (1000 ft) long trough, which has a closed depression near its northeast end, is similar in orientation to other northeast-trending scarps and troughs higher on the ridge to the southeast. All of these features are believed to be due to landsliding and lateral spreading of the ridge toward the northwest. A detailed map prepared by Northern

(FIG. 11).—Map of country north of Shelter Cove, Humboldt County, showing auxiliary faults in relation to main fault.

The auxiliary fault trace E of Matthes could not be verified as a fault (although it may in part have been a landslide feature activated in 1906) and should be withdrawn from zoning. It is further noted that Matthes showed this fault trace as queried, distinguishing it from his other mapped traces.

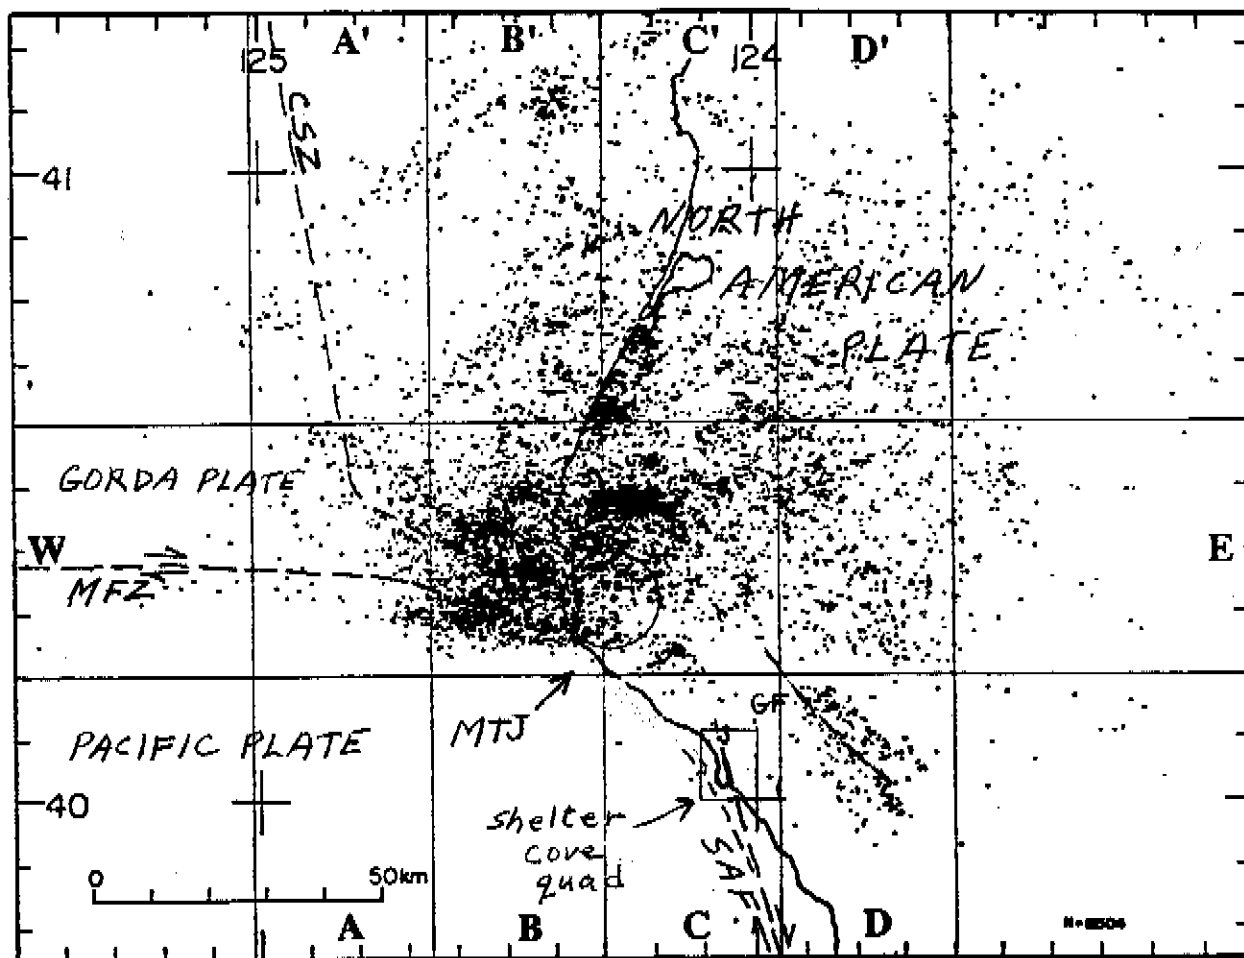
The northern San Andreas Fault is not currently associated with earthquakes, indicating that the Pacific - North American plate boundary is locked. According to Hill and others (1990), the northern San Andreas Fault has been nearly aseismic at least since the mid-1930's when reliable instrumental data became available. However, a northwest-trending zone of seismicity east of the Shelter Cove quadrangle suggest activity on the Garberville Fault (Figure 6).

Figure 6 (FER-243). Map showing seismicity of the Mendocino Triple Junction (MTJ) region (from McPherson, 1992). Location of MTJ based on McLaughlin and others (1994). San Andreas Fault (SAF), Mendocino Fracture Zone (MFZ), and seaward edge of the Cascadia Subduction Zone (CSZ) separate the principle tectonic plates. GF is the Garberville fault.

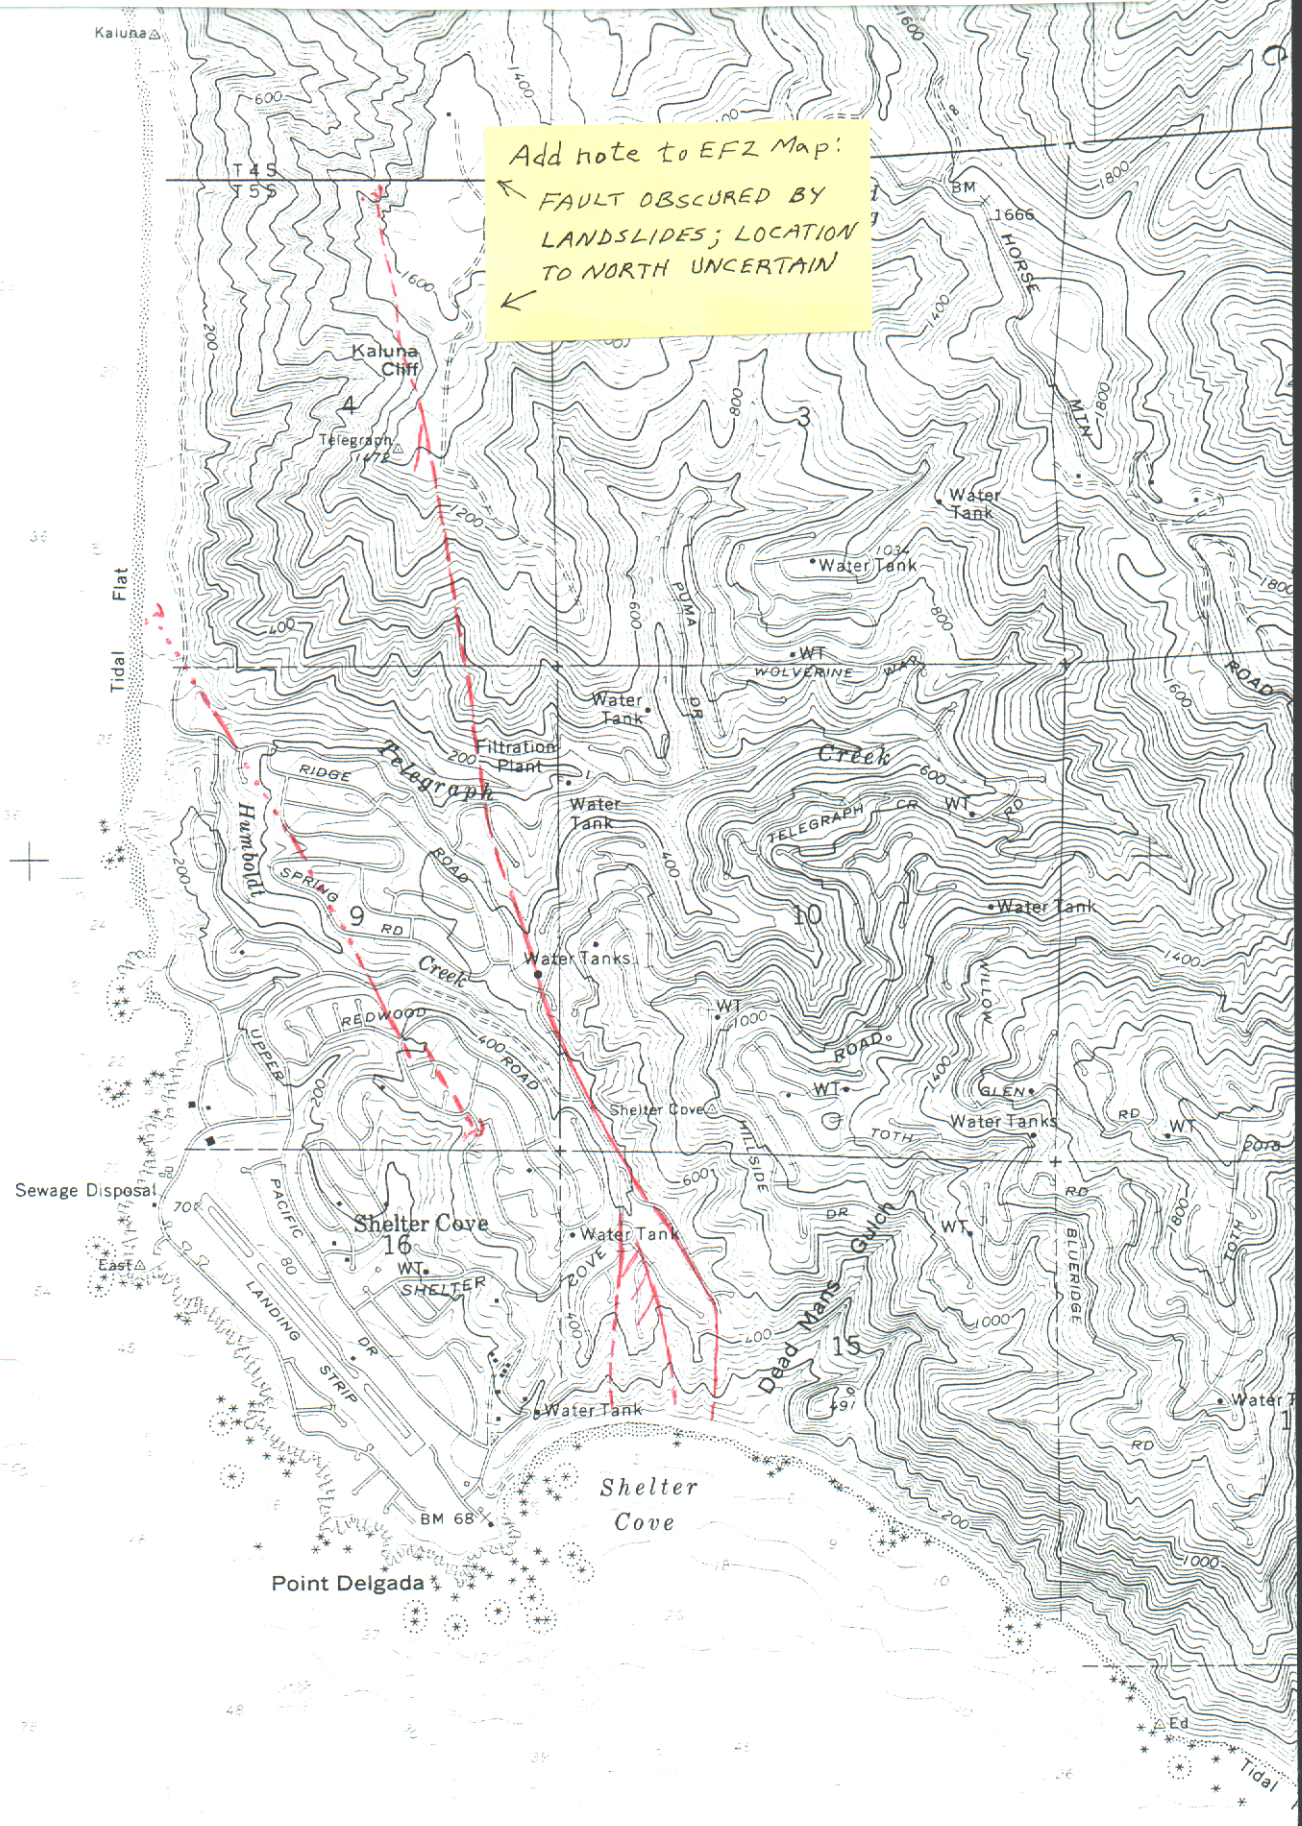
Figure 8 (FER-243). Map of Holocene-active fault traces in the Shelter Cove 7.5-minute quadrangle recommended for revised zoning of the SE¼ Point Delgada Earthquake Fault Zones Map. Locations of fault traces are based on Hart (this FER), except for the main trace north of "Telegraph 1472", which is based on Muller (1996).

Based on information presented here, it is recommended that the Earthquake Fault Zone shown on the SE¼ Point Delgada quadrangle be revised to reflect the revised locations of the main and auxiliary traces (includes traces C and D of Matthes) of the San Andreas Fault as shown on Figure 8. These faults meet the zoning criteria of sufficiently active (i.e. Holocene) and well-defined as described in Hart (1994). The fault traces shown on Figure 8 are based on this FER (Hart, 1996) with the exception of the main trace north of "Telegraph 1472", which is from Muller (1996).

Since the fault is not well-defined north of Kaluna Cliff, the zone should be terminated a short distance to the north. A note should be placed on the EFZ map to reflect the uncertainty of the fault's position to the north and/or the fact that the fault is obscured by landslides in that area.
